# *Jerome Landslide*

## *POTENTIAL CAUSES OF LANDSLIDE AND PROBABILISTIC APPROACH TO ASSESSING FUTURE RISK OF MOVEMENT*

*Scott D. Neely, P.E.  
Geotechnical Services Manager  
Terracon, Inc  
&  
ADOT Materials Group*

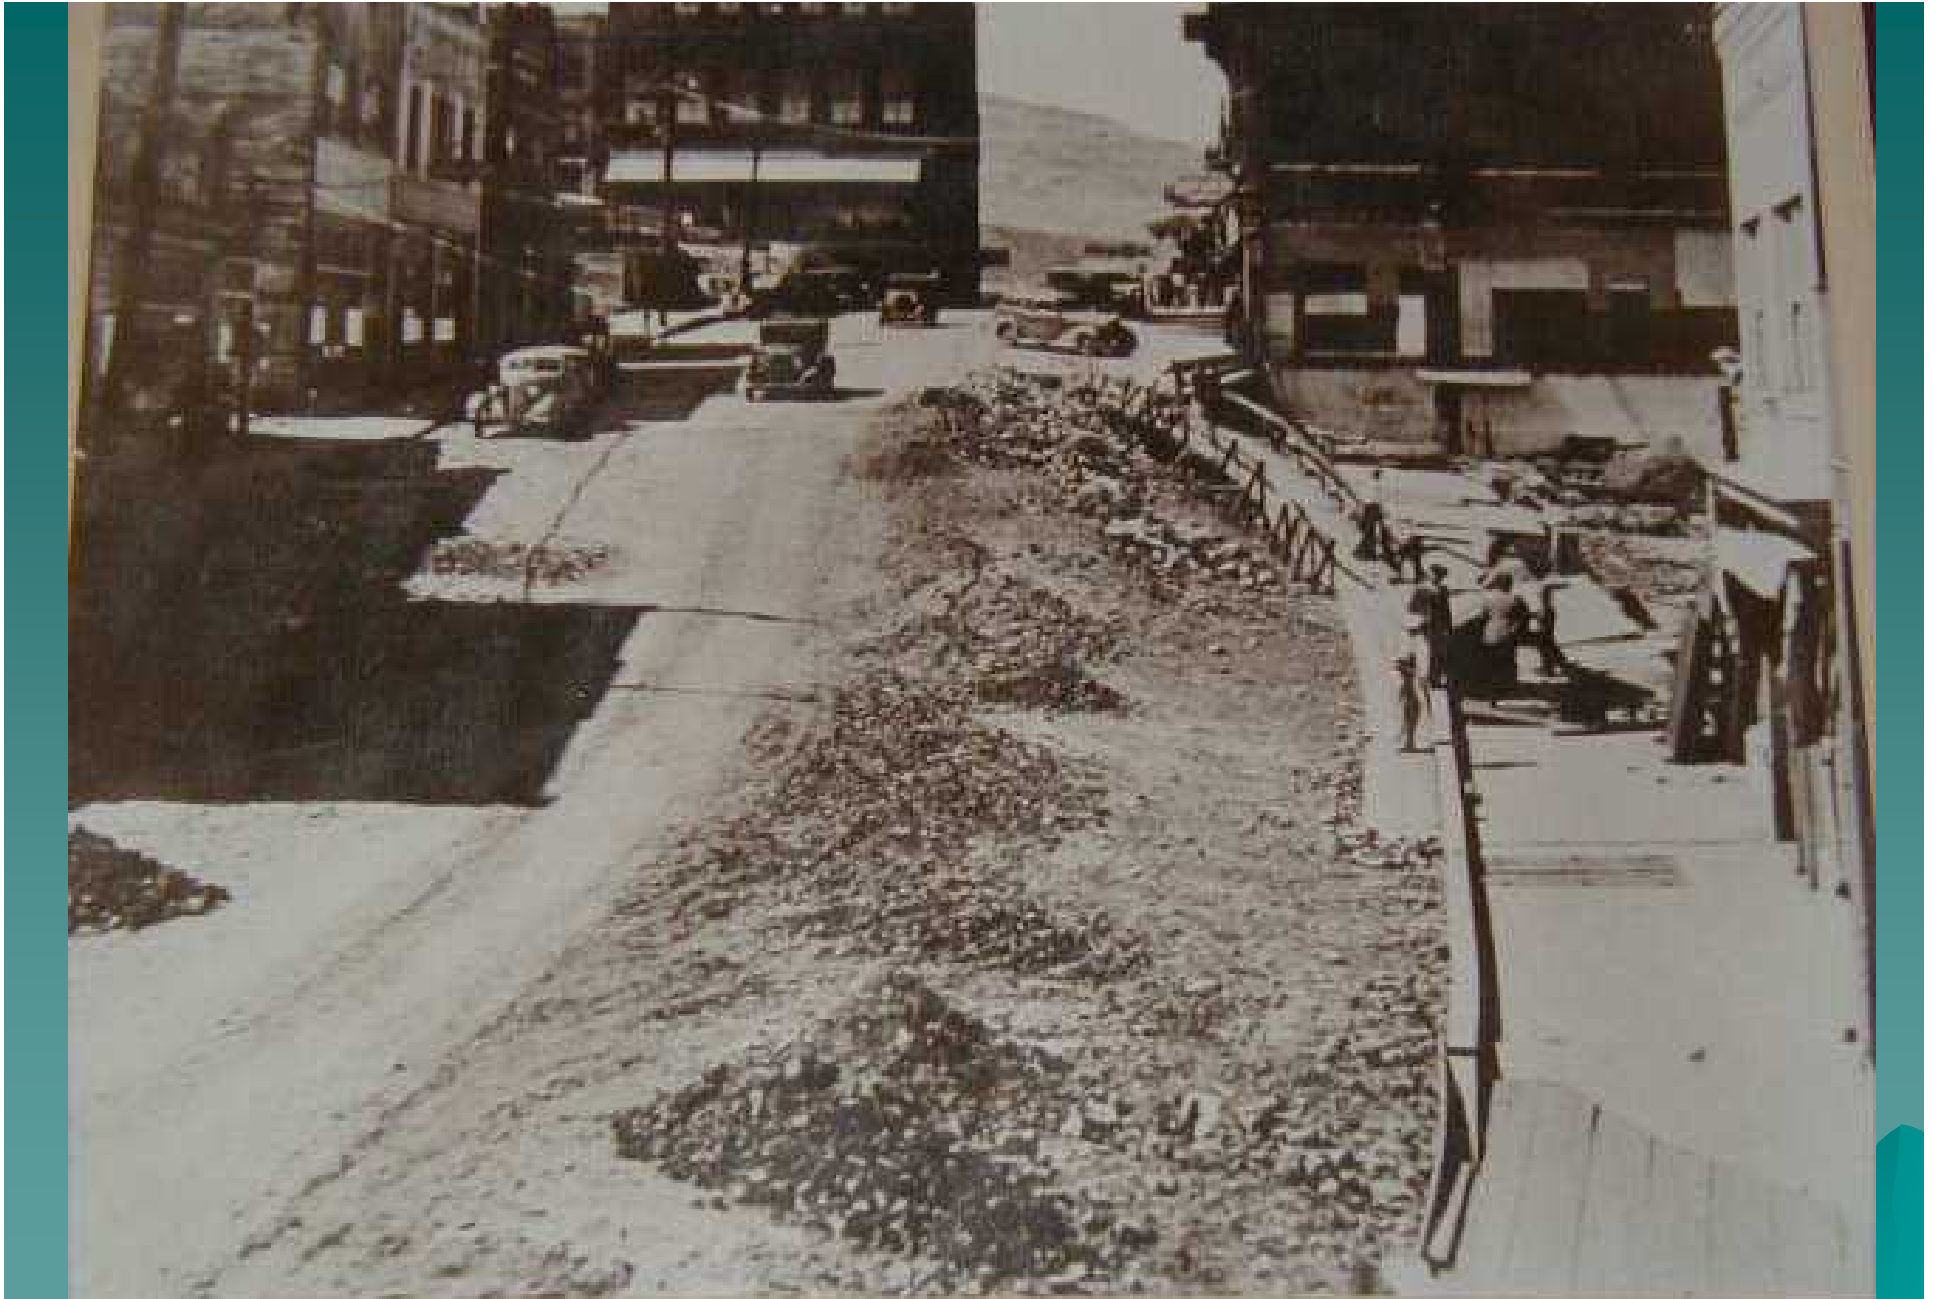
This lot once contained the second largest J.C. Penney store in the chain. As the store slipped away from the

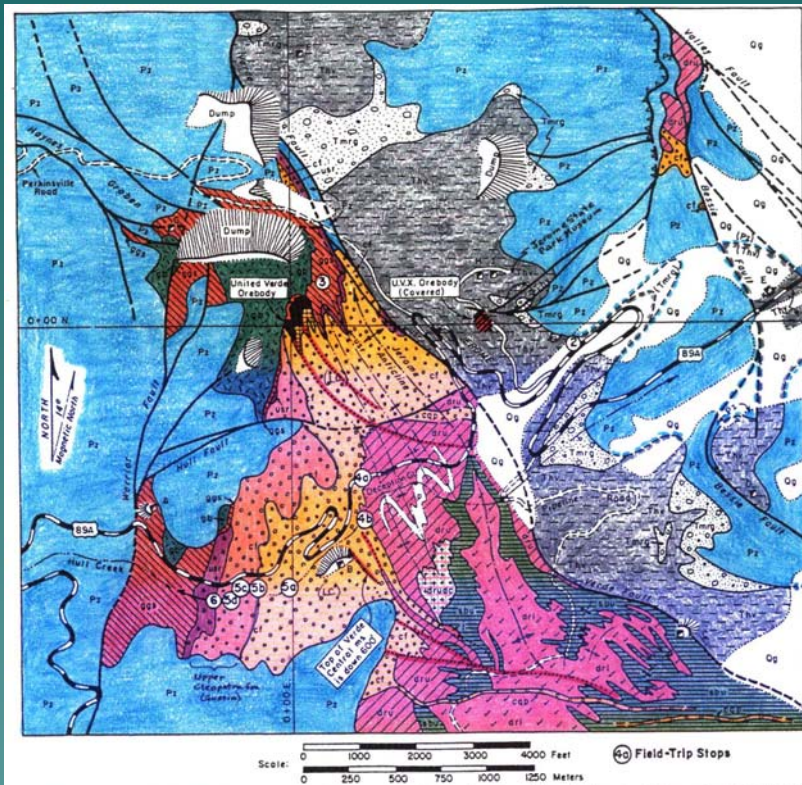
Figure 2. Simplified geologic map of the Jerome area, Verde district, Yavapai County, Arizona (modified from Lindberg, 1986a). Post-1971 detailed contact mapping modifies the interpretations and nomenclature of Anderson and Creasey (1958) and Anderson and Nash (1972). Current informal district usage is given below.

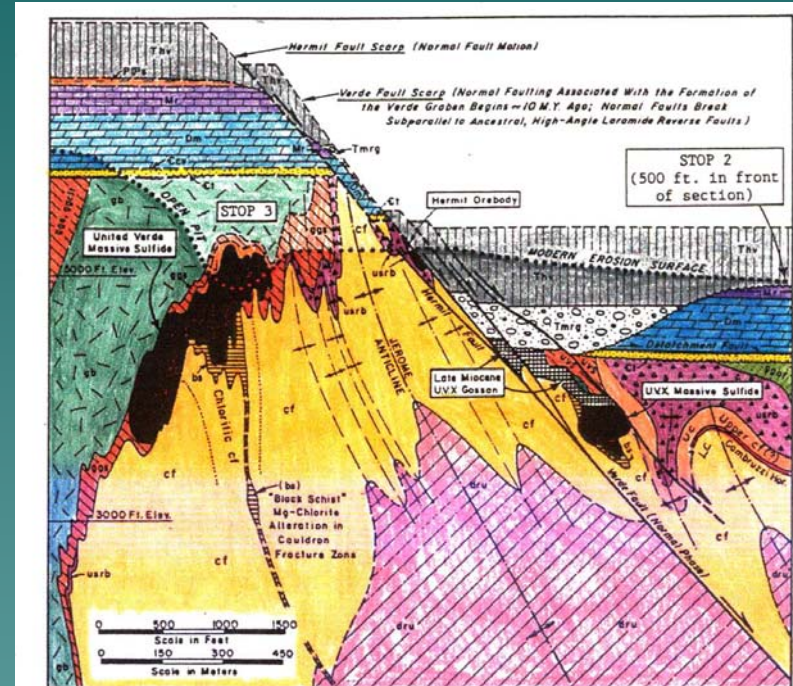
Figure 3. East-west cross section, looking north, through the Jerome anticlinorium. Geologic notations are given in Figure 2. The time is about 10 Ma when normal Verde graben faulting began. The United Verde and U.V.X. are separate orebodies which are now located on opposite limbs of the fold system.
